date
client
project
TLX ref

The TLX Gold solution: 75mm rafters + 50mm PIR at 400mm centres

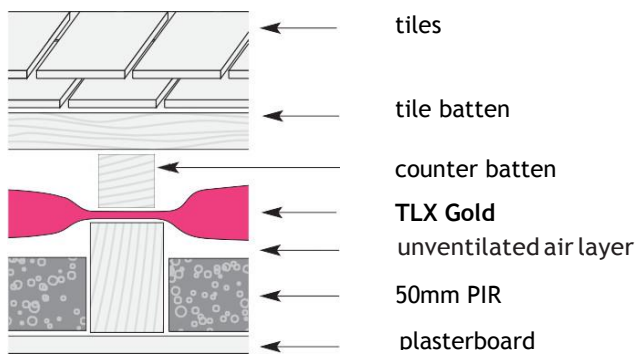
- Remove tiles, tile battens and old felt.
- Fit 50mm PIR rigid board closely between rafters.
- Fit TLX Gold taut across the rafters, creating a 10mm unventilated air space.
- Fit 38 x 38mm counter battens vertically down the roof
- Fit tile battens, then tiles or slates

Renovated roof U = **0.34 W/m² K**

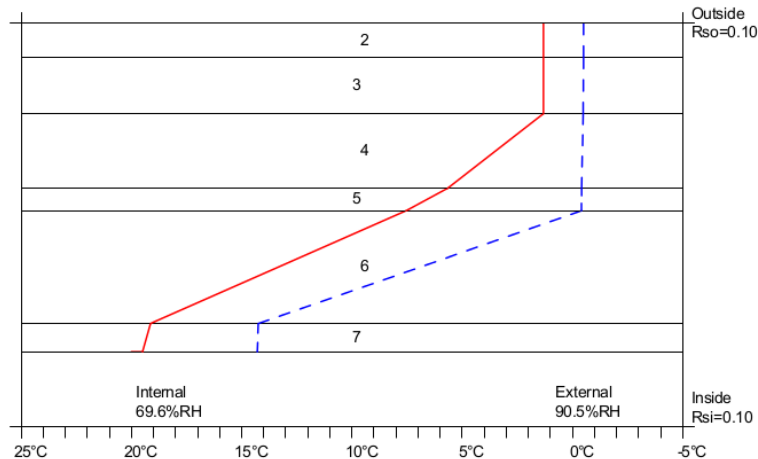
Condensation risk analysis

Interface Temp.	Dewpoint Temp.	Vapour Pressure (kPa)	Saturated V.P. (kPa)	Worst Cond. (g/m ²)	Peak Buildup (g/m ²)	Condensation
1 Outside surface resistance							
	1.3	-0.5	0.59	0.67			No
2 Clay tiles (BS5250)	1.3	-0.5	0.59	0.67			No
3 Ventilated air gap	1.3	-0.5	0.59	0.67			No
4 TLX Gold	5.6	-0.4	0.59	0.91			No
5 Unventilated air gap	7.5	-0.4	0.59	1.04			No
6 PIR	19.1	14.2	1.62	2.21			No
7 Plasterboard	19.5	14.3	1.63	2.26			No
8 Inside surface resistance

Worst case internal / external conditions for graph : 20.0°C @ 69.6%RH / 0.8°C @ 90.5%RH

The condensation risk analysis given above shows that the temperature through the roof structure remains above the dew point, and there is no risk of interstitial condensation.

As shown, there is no risk of interstitial condensation with this detail and it complies with the standards set out on BS5250.
