## The TLX Gold solution: 100mm rafters + 50mm PIR at 400mm centres

### TLX Gold Solution - 100mm rafters + 50mm PIR at 400mm centres

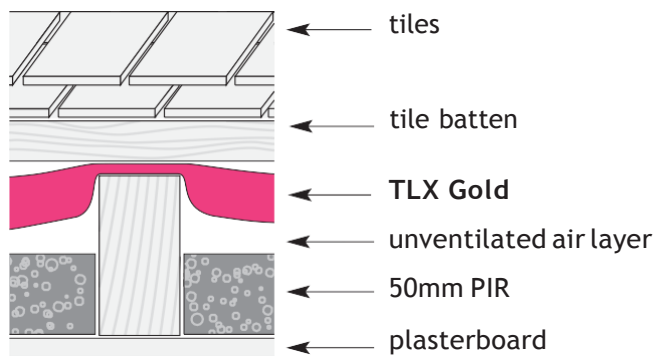
- Remove tiles, tile battens and old felt.
- Fit 50mm PIR rigid board closely between rafters.
- Drape TLX Gold into remaining rafter space, creating a 10mm unventilated air space.
- Fit tile battens, then tiles or slates

Renovated roof U = **0.33 W/m<sup>2</sup> K**

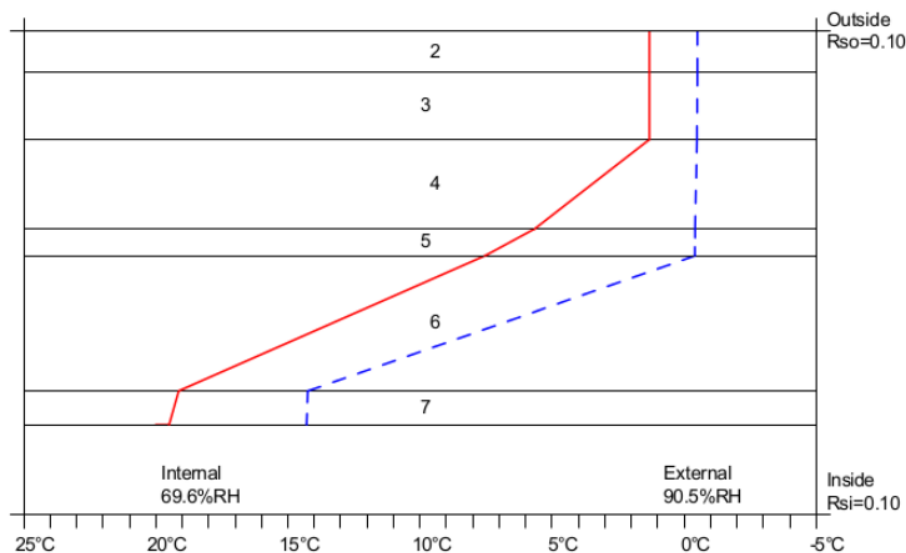
## Condensation risk analysis

Worst case internal / external conditions for graph : 20.0°C @ 69.6%RH / 0.8°C @ 90.5%RH

The condensation risk analysis given above shows that the temperature through the roof structure remains above the dew point, and there is no risk of interstitial condensation.

As shown, there is no risk of interstitial condensation with this detail and it complies with the standards set out on BS5250.
